Manhole Inspection Summary

Manhole # S25G__019MH

Location Address: **9 CARROLLTON AVE**

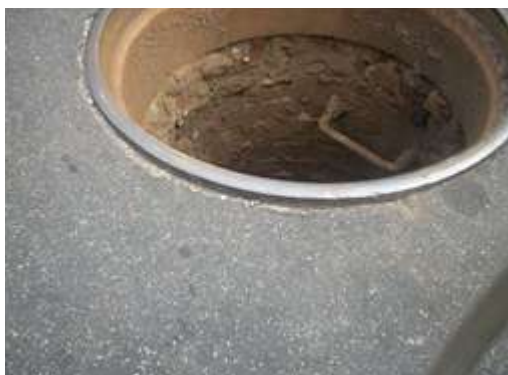
Defect 5

Diameter: **25.** (in.) Length: (in.) Dist A/B Grade: **0.5** (in.)
75

GRADE ADJUSTMENT

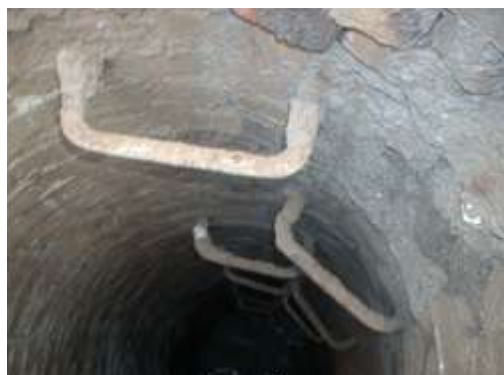
Defect 4

Count: **13** Missing: **0** ☒ **Corroded**

CORRODED STEPS

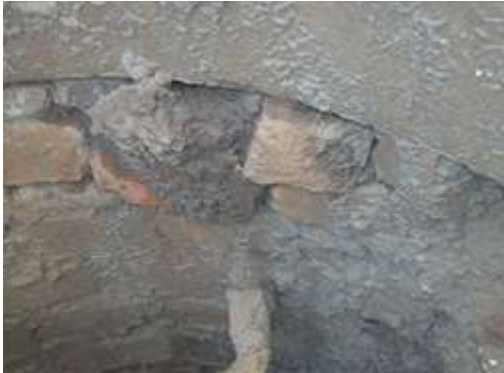
Defect 3

Condition: ☐ Sound ☐ Cracked ☐ Root Intrusion ☒ **Loose Brick** ☒ **Deteriorated**

DETERIORATED CHIMNEY/LOOSE BRICKS

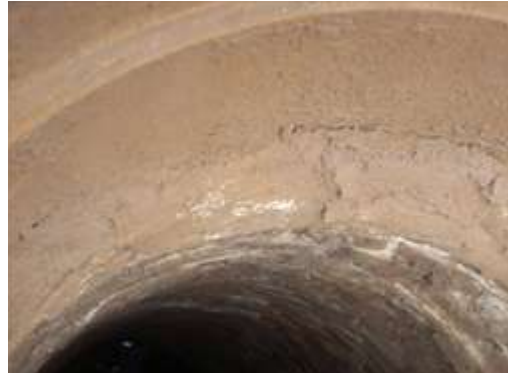
Defect 2

Offset: **1** (in.)

FRAME OFFSET

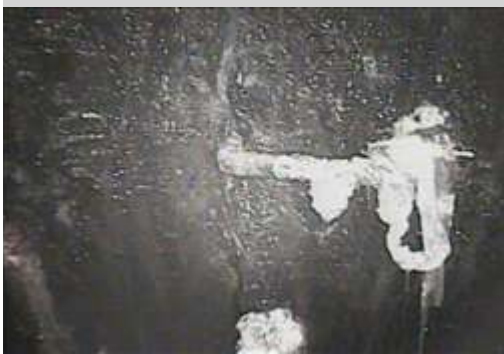
Defect 1

☒ **Evidence Of Surcharge** Depth: **4** (ft.) ☐ Active Surcharge Present

SURCHARGE EVIDENCE ON THE STEP

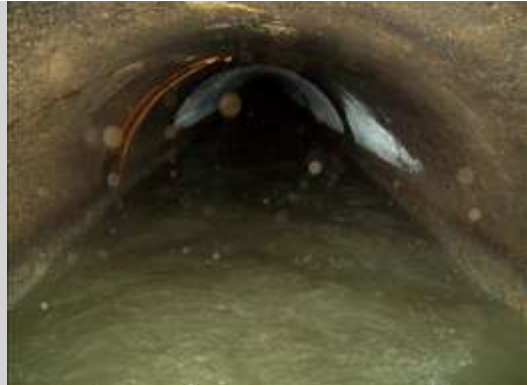
12 O'Clock Outflow

54 in. Circular Gravity Sewer
Pipe Out @ 12 O'Clock

Infiltration: **None** Pipe Seal Cond: **Sound**

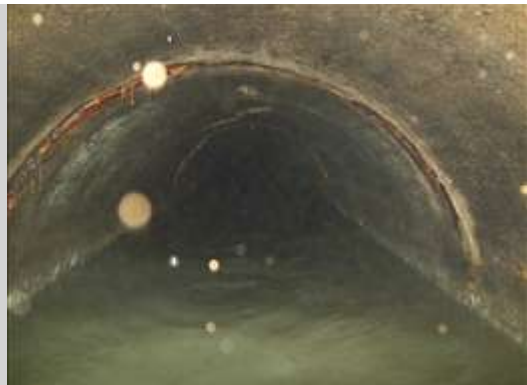
6 O'Clock Inflow

54 in. Circular Gravity Sewer
Pipe In @ 6 O'Clock

Infiltration: **None** Pipe Seal Cond: **Sound**

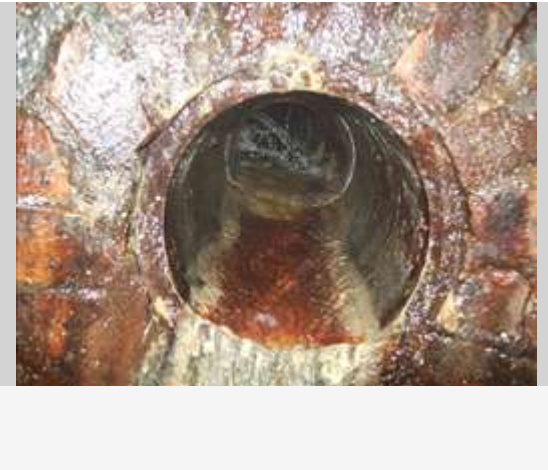
9 O'Clock Inflow

8 in. Circular Gravity Sewer

Infiltration: **None** Pipe Seal Cond: **Sound**
